STUDIES OF FAST REACTOR FUEL ELEMENT BEHAVIOR UNDER TRANSIENT HEATING TO FAILURE

II. In-pile Experiments on UO_2 Samples in the Absence of Coolant

January 1965

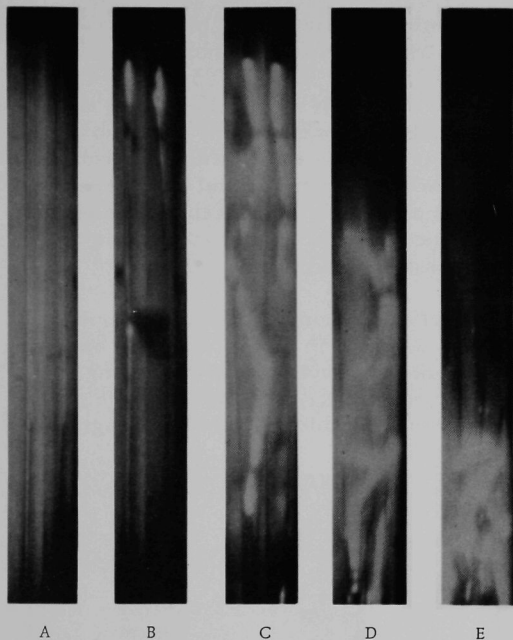
Fig. 7
Photographs of Failure of Stainless-
steel-clad Oxide Sample Subjected
to 176-MW-sec Transient

The first photographic records of oxide sample failure came from stainless-steel-clad specimens 2 and 3 of the third oxide series (XXVIII). Failure was nonviolent, and occurred just before cladding melted. Figure 7 consists of still black-and-white prints taken from the color film of the failure of sample 3 of Series XXVIII. Figure 7A shows the specimen intact at the beginning of the reactor transient; the element, proper, is at the left, and its image appears at the right in a mirror located at the end of the Zircaloy capsule. Figure 7B shows the element after the reactor excursion was over at the time of failure. The triangular dark patch near the center is attributed to "charring" of the plastic paint in the powdered alumina-white paint mixture that is used to coat the capsule walls to provide a diffuse white background for the photography.* This blackening could

have been caused by a sudden expulsion of hot gas from the cladding upon failure. Figures 6C, 7D, and 7E show individual frames from the subsequent collapse of the sample under the influence of gravity as the cladding temperature reached the melting point.

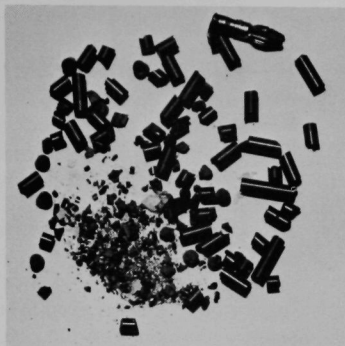
Fig. 12. Series XXV Fragmented Oxide from Samples 1 (top) and 2 (bottom)

2. Series XXV Dry Opaque (Four Samples). No evidence of cladding failure occurred in any of the specimens. The spacer wires on samples 1 and 2, by uncoiling, produced extensive twisting and warping of the elements with consequent local fragmentation of the oxide. The extent of fragmentation is shown in Fig. 12. Samples 3 and 4, although not warped, contained about the same amount of fuel fragments, plus some fines or oxide dust (see Fig. 13). Microscopic examination showed the oxide from samples 1, 2, and 3 to be unchanged or like the unirradiated

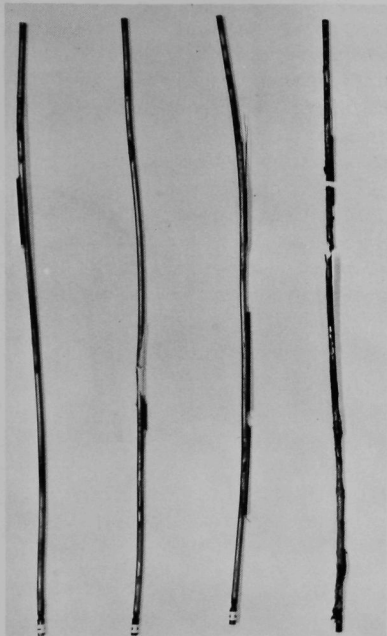
Fig. 15. Refractory-metal-clad Samples 1 through 4 (left to right) of Series XXXII

4. Series XXXII Dry Transparent (Four Samples). The postirradiation condition of the two niobium-clad (1 and 2) and two tantalum-clad (3 and 4) samples is shown in

b. Sample 2. The sample was slightly warped. A small hole was found in the cladding at a point 22 cm from the bottom. The cladding diameter increased by about 0.005 to 0.008 cm. From the rise in activity recorded at the fission gas trap in the capsule-cover gas system, it was concluded that the hole was produced during the transient test. Fuel slugs from samples 1
